Failure Analysis and Repair of a Broken Extruder Shaft: A Case Study

Salem Ali Karrab and Mohamed Ali Ballem

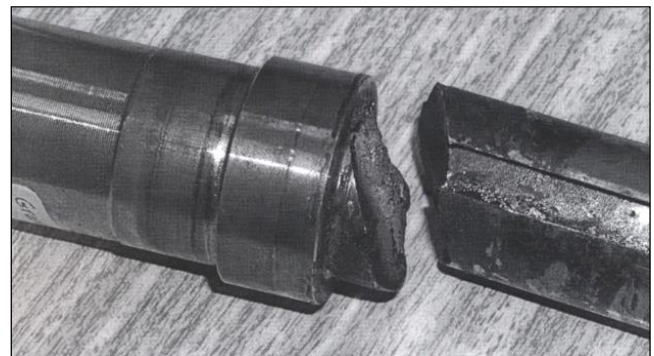
When the extruder was tripped in January 2002, the shaft was found to break into two pieces at the coupling area approximately 550 mm from shaft end as shown in Fig. 2. After dismantling detailed inspection revealed severe mechanical damages in the barrel internal surface, and deep grooving up to 3 mm deep on screw elements as shown in Fig. 3, these were ascribed to overlap of both shafts on each other. This wearing in the screw elements and/or barrels creates a clearance up to approximately 26 mm. Also as a result of cracking, screw shaft tip was found broken and visco-seal ring was found damaged. Definitely it is valuable to mention that before failure an abnormal level of vibration was recorded many times, as well as metal powder was detected in the final product.

Fig. 2. General view of the failed screw shaft

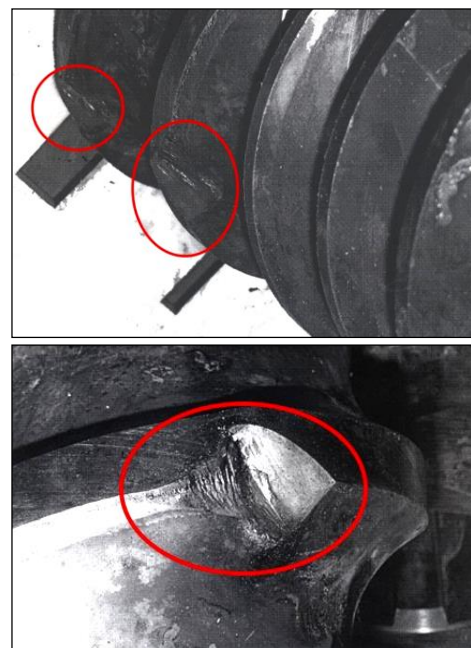
Fig. 3. Mechanical wear of the screw elements

- 5) Replace and/or weld repair on wearing and grooving in screw elements and barrels.
- 6) Regular check the alignment of all extruder components, especially at coupling between the motor and gear box, and between the gear box and the screw shaft, since misalignment causes cycle bending stress that leads to fatigue failure [16], [22].

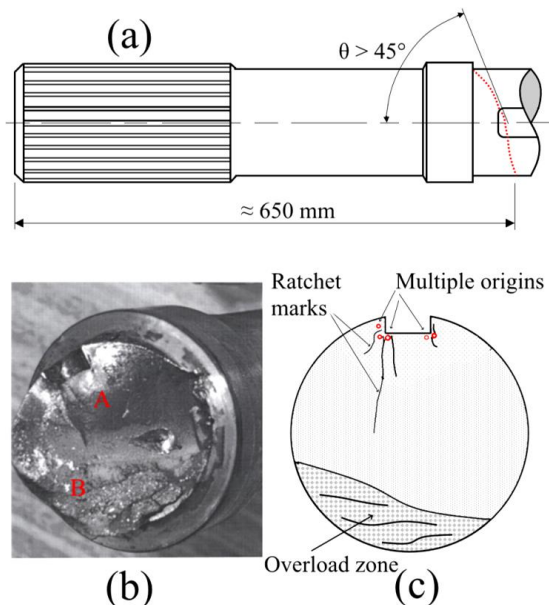
Fig. 4. (a) The approximate location of the fracture, (b) overview of the fracture surface, and (c) a schematic illustration of the fracture surface

Visual examination is one of the first steps of any failure analysis process and remains the cornerstone of any failure examination; it is very important to perform this stage prior to any altering of the failed component. Photography and/or videotaping are used as visual documentation to obtain a permanent record of the studied case [14]. Fig. 2 shows a photograph of the broken screw shaft, it is obvious that the shaft failed at the keyway and the fracture travels across the shaft cross-section, climbing toward the stepped portion of the shaft. Further observation of the recorded photograph (Fig. 2) revealed that the fracture surface is orientated with an angle greater than 45° with respect to the shaft centerline. The approximate location of the fracture is about 650 mm from the splined end of the shaft as illustrated in Fig. 4a; the appearance of fracture surface is shown in Fig. 4b, it is observed that the fracture surface consists of two different zones: the first zone is relatively smooth indicated with the letter A, while the second one has a rough surface and indicated with the letter B.

Torsional-bending fatigue mechanism is further supported by carefully analyzing the data provided in visual observation section, beginning from the orientation of the fracture face with respect to the shaft centerline, when the angle of the failure surface is approximately 45° it is a clear indication that fracture is due to torsional fatigue [14], [17]–[20], however in the presented case the angle is midway between 45° and 90° , thus the failure was not only due to torsion force but the combination of both torsion and bending forces caused the fatigue failure [17], [18].

Close observation of the fracture surface shown in Fig. 4b revealed features of a typical fatigue failure surface; the cracks initiated at some points that have high stress concentration located at the corners of the keyway as illustrated in Fig. 4c; keyways are common stress raisers in shafts and probable sources of fracture origin [14], [17], [19], the fracture surface near origins i.e. at crack initiation and at crack propagation sites is usually smooth and then the surface becomes rougher as the original cracks increase in size. It can be noticed that this region contains of ratchet marks, these marks indicating multiple origins fatigue and the crack origin will be separated by ratchet marks and located approximately midway between the two marks (Fig. 4c). Also, there is no evidence of the so called “beach marks” or “progression marks”, such observation usually noticed with parts that operated continuously, or with only brief stoppages in service, and could be due to the friction of the two fracture surfaces of the crack against each other every cycle of the rotating part [19]. The final fracture surface shows a brittle cleavage failure with a rough texture, this region is known as the overload zone and its size indicates the magnitude of the load or stress when the final fracture occurs; in the studied case the final fracture zone is relatively small compared to the shaft cross-section indicating a high-cycle fatigue failure [14], [17]–[21].

- 7) Regular check the clearance between the two screws and between the screws and the barrel and ensure that they are within the design limits.
- 8) During the maintenance or when dismantling the extruder for regular inspections the sites that considered as stress raisers such as, steps at changes in diameter, holes, abrupt corners, keyways, splines, grooves, threads, ...etc. have to be checked carefully.

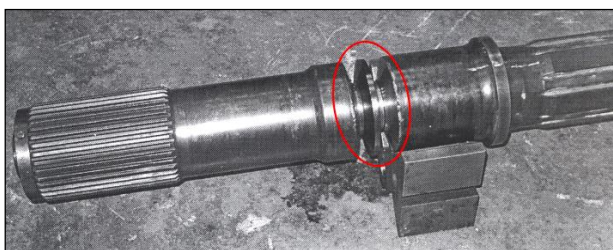
Fig. 5. The fabricated adaptor inserted between the two pieces of the broken shaft

- 5) Inserting the threaded adaptor into threaded holes and tightening as shown in Fig. 5, and then followed by buildup weld repair.
- 6) Application of the necessary nondestructive testing (NDT) such as, visual inspection (VI), dye penetrant testing (DPT), and magnetic particle testing (MPT) on all weld area.

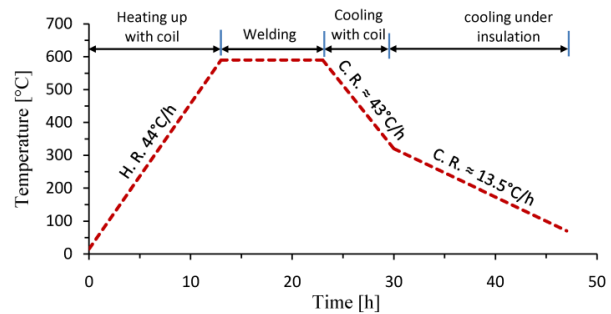
Fig. 6. Pre-weld heat treatment procedure

- 1) Preheating the shaft end with heating coil (shown in Fig. 7a) before welding at rate of 44°C/h up to 590°C .
- 2) After welding, the shaft is cooled under coil with rate of 43°C/h up to 320°C .
- 3) Remove heating coil and continue cooling the work piece using fiberglass blanket insulation (shown in Fig. 7b) with rate of 13.5°C/h to temperature of 70°C .

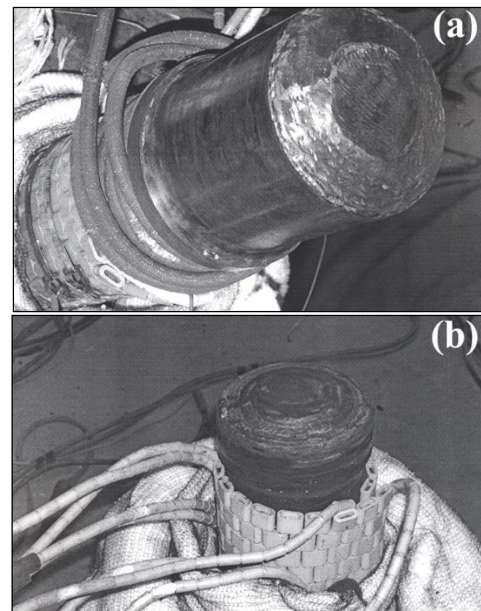
Fig. 7. Installation of (a) the heating coil and (b) the insulation blanket around the shaft

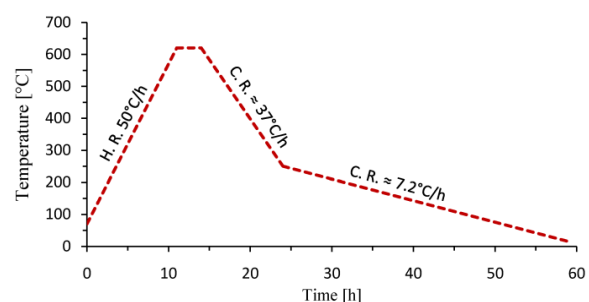
Fig. 8. Post-weld heat treatment procedure

- 1) Heating the work piece to 620 °C with heating rate 50 °C/h
- 2) Soaking the work piece at this temperature for 3 hours
- 3) Start cooling the work piece with cooling rate of 37 °C/h to 250 °C
- 4) Continue cooling the work piece with cooling rate 7.2 °C/h to room temperature.
